### Division of Oil, Gas & Mining

SUBJECT: Site Inspection, H.E. Davis Construction, Chicken Creek,  
M/023/016, Juab County, Utah

Date of Inspection: May 18, 2004  
Time of Inspection: 11:50 a.m.  
Conditions: Sunny, warm  
Participants: John Childs, Kay Christofferson, Tony Christofferson - H.E. Davis; Tom Lloyd - USFS; Doug Jensen, Paul Baker, Wayne Hedberg and Tom Munson - DOGM

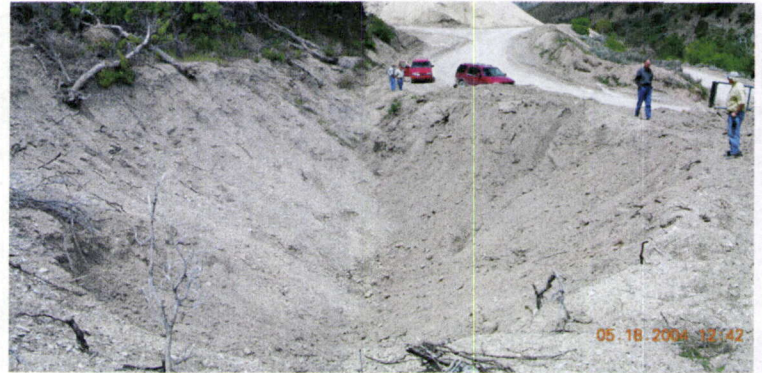
PANO-SEDPOND.JPG

We looked at the sediment control in both the pond, the ditch going to the pond. It looks better than it did. We also looked at the road adjacent to that ditch, which is the access road to the mine. They stated they were going to add some fill on that road and slope it into the hill and then have a catch basin and outlet put in place.

We expect updated aerial maps and the sediment controls in place by the next inspection.

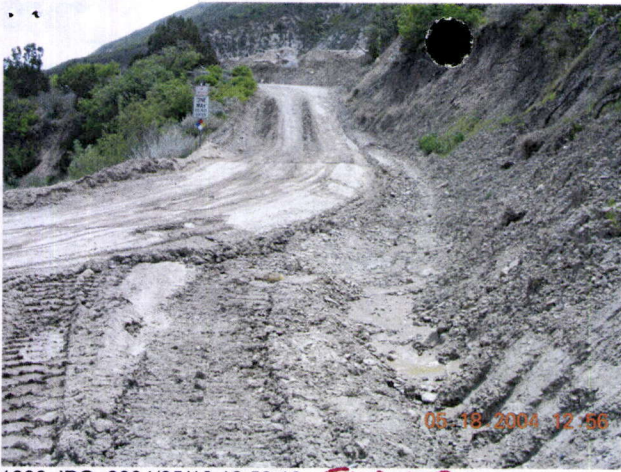
DSCN1680.JPG 2004/05/18 12:56:18 *EXIT ROAD*

On the exit road, they will construct a sediment trap consisting of a basin and a check dam. We gave them until the end of the month to complete that as well.

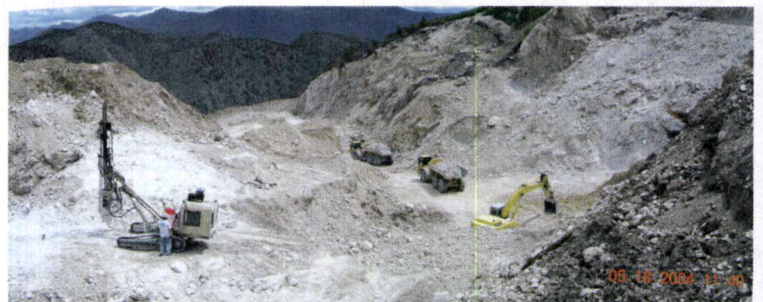
*UPPER PIT*

**Observations:** We began this inspection by looking at the pit are on top of the hill, which is significantly larger than the last time we were here. We will not know how much larger until we get the actual aerial maps.
